TO CLOSE OR NOT CLOSE?

The decision to keep roof tank drains open or closed is an operating dilemma faced by tank farms worldwide. **Michael Sprung and Mark Rauch, EnviroEye, LLC, USA, and Chris Chase, InterOcean Systems, USA**, outline a newly developed system that can help operators to safely and effectively monitor floating roof drainage.

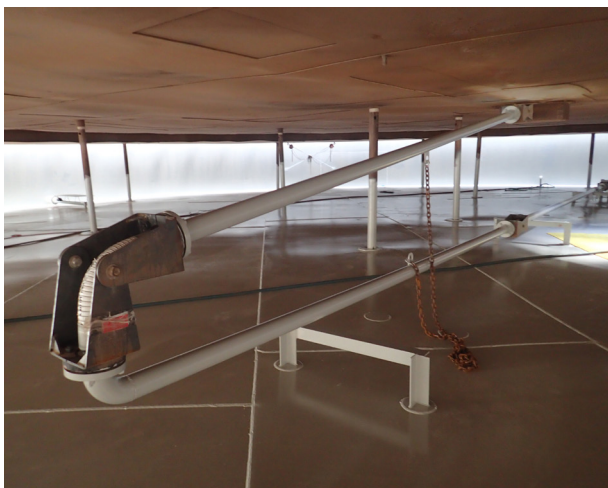
Figure 2. Inside an AST – articulated floating roof drain line.

When leaving the roof drain open, with the expectation of slight or torrential rains, all rainwater immediately drains from the roof through and out of the tank. The risk in this scenario is, if the internal roof drain line fails, the stored product drains through the failed line onto the ground, causing hazardous material to discharge into the tank dike.

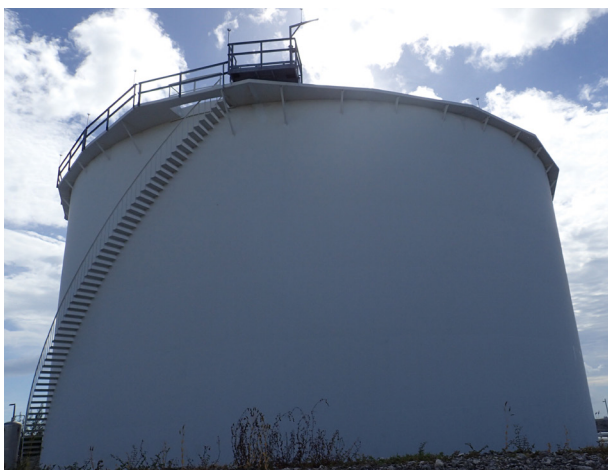
Figure 3. AST with floating roof.

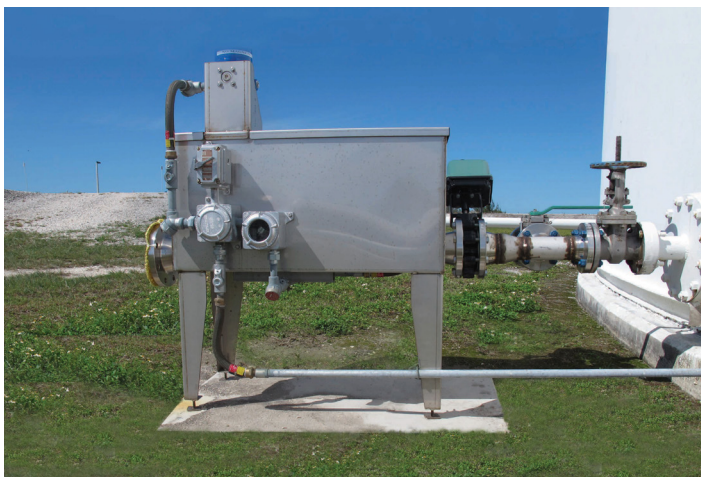
Figure 4. EnviroEye system.

In an attempt to solve this dilemma, the EnviroEye system has been developed by a group of AST storage facility operators, offering a potential solution for the long standing ‘open or closed’ quandary. EnviroEye has created a flow chamber that slows the escaping liquid from roof drains, while subsequently creating an ideal point for monitoring and detecting any hydrocarbons present in the stormwater discharge from AST roofs, and for automatically containing accidental leaks or spills. The EnviroEye system attaches by flange directly to the roof drain flange – a bypass valve is recommended at this junction. Between the tank and the unit, an automated valve is used to automatically stop the flow any time hydrocarbons are detected.

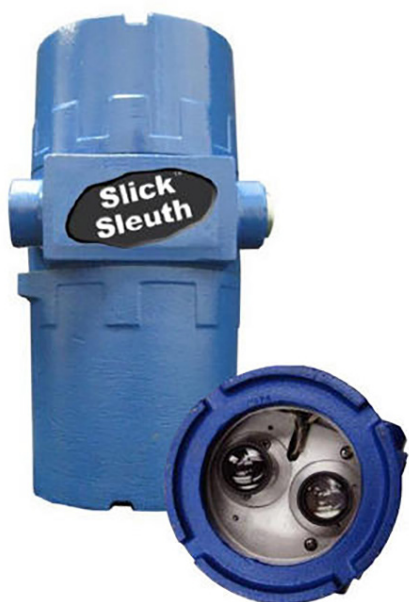
Figure 5. Slick Sleuth SS100 oil detector.

sensor is mounted at the end of the flow chamber, where water flows through a controlled path and passes within view of the optical sensor. The sensor itself uses UV-fluorimetry to detect the presence of petroleum and hydrocarbon-based products on the surface of the water, activating an audible, visual, text or cloud-based message that can be investigated by designated facility personnel. This optical method of detection is highly sensitive to both sheens and slicks, and offers adjustable sensitivity thresholds that can be set by operators. Furthermore, because it is a non-contact system (no contact with water or product), there is very little need for maintenance.

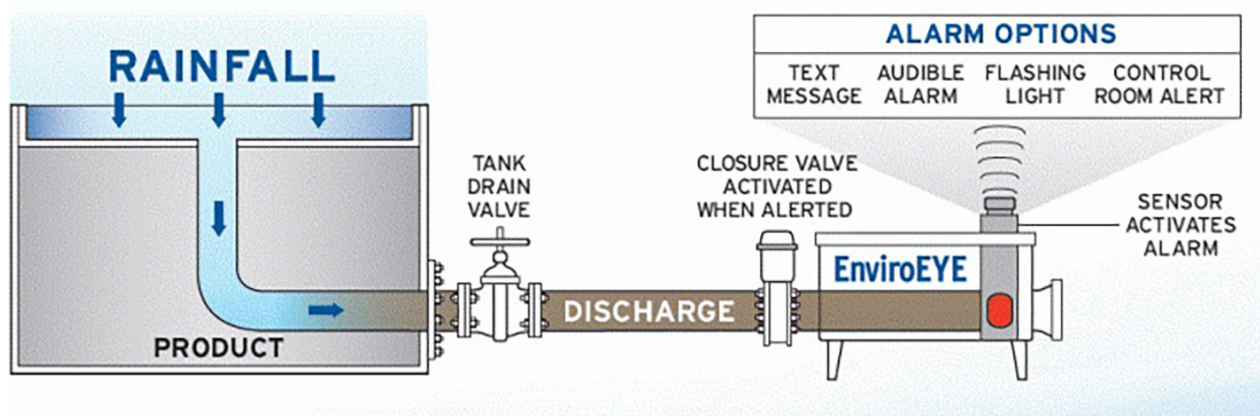
Figure 6. Diagram of EnviroEye system.

Overall, the EnviroEye system has been developed to provide tank farm operators with a tool to manage stormwater discharge from floating roof ASTs; however, the system can be customised with different components, depending on its intended use. There are bypass valves and additional actions that can send the contaminated liquids into sump/holding areas. The design and size of the flow chamber, as well as other component details and specifications, are determined by the tank diameter, height, drain line size, climate and operator protocols. Whether the requirement is for AST floating roof tanks, for stormwater runoff, water retention-containment ponds for oil-related sites, or diked areas surrounding hydrocarbon tanks, there is an arrangement that can be configured to meet any given set of application and location requirements. EnviroEye uses only Class 1 Division 1 Explosion Rating (NFPA 70) components on the flow chamber.⁴
